ADDITIONAL RESULTS ON SPACE ENVIRONMENTAL EFFECTS ON  
POLYMER MATRIX COMPOSITES — EXPERIMENT AO180

R. C. Tennyson  
University of Toronto Institute for Aerospace Studies  
Toronto, Ontario, Canada  
M3H 5T6

ABSTRACT

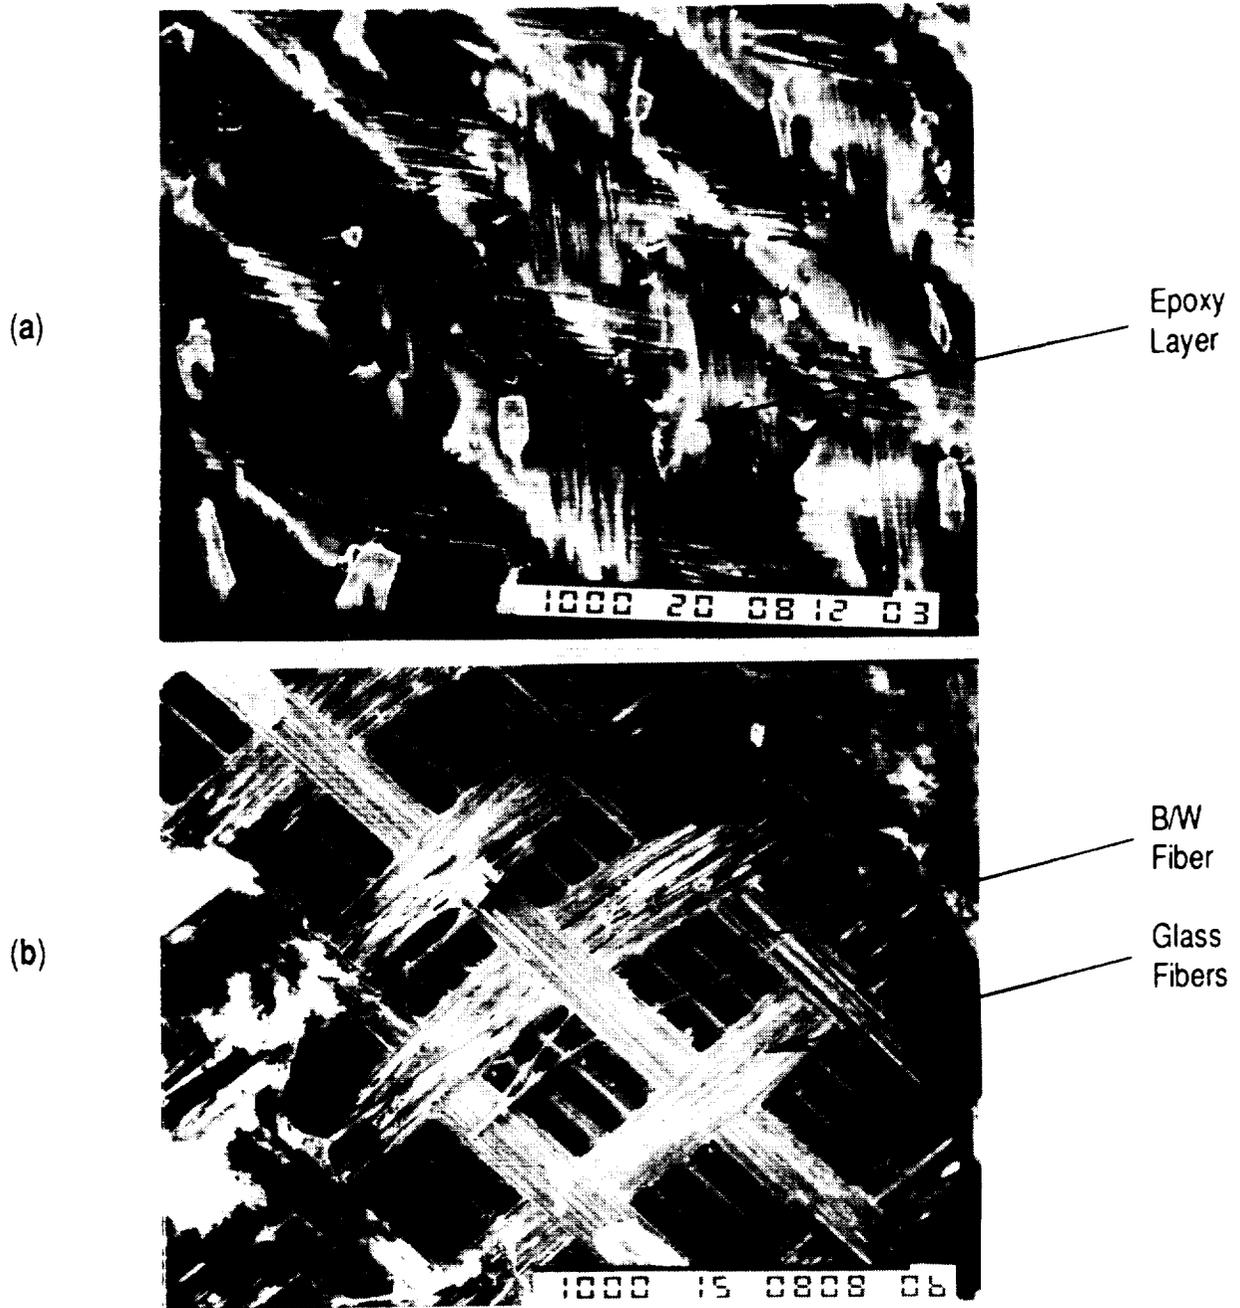
The erosion of boron/epoxy laminates was restricted to the outer epoxy layer. Figure 1 shows a comparison of the unexposed (a) and exposed (b) areas, where it is evident that loss of the outer epoxy layer reveals the woven glass fiber cloth (used as a binder material) and the unidirectional boron (coating over tungsten) fibers. Cross-sectional views (Figure 2) show the outer resin layer, glass fibers and composition of the reinforcing 'boron' fiber with its tungsten core. Figure 3 presents a similar view including the AO erosion profiles of the epoxy layer. For a tube structure, the erosion angle varies with circumferential position around the tube, as demonstrated by the results plotted in Figure 4. Finally, close-up examination of the boron fibers exposed to AO reveals a grain structure (Figure 5) that has formed in the boron coating, although no loss of boron material due to erosion was observed. The combination of boron reinforcing fibers overlaid with glass fiber scrim cloth yields a laminate that is significantly less sensitive to AO erosion than graphite and Kevlar® reinforcements.

Fig. 1 SEM Photographs of Boron/Epoxy Tube Surface [SP-290,  $(\pm 45^\circ)_4S$ ] (a) Unexposed (x50), (b) Exposed to Atomic Oxygen (x50)

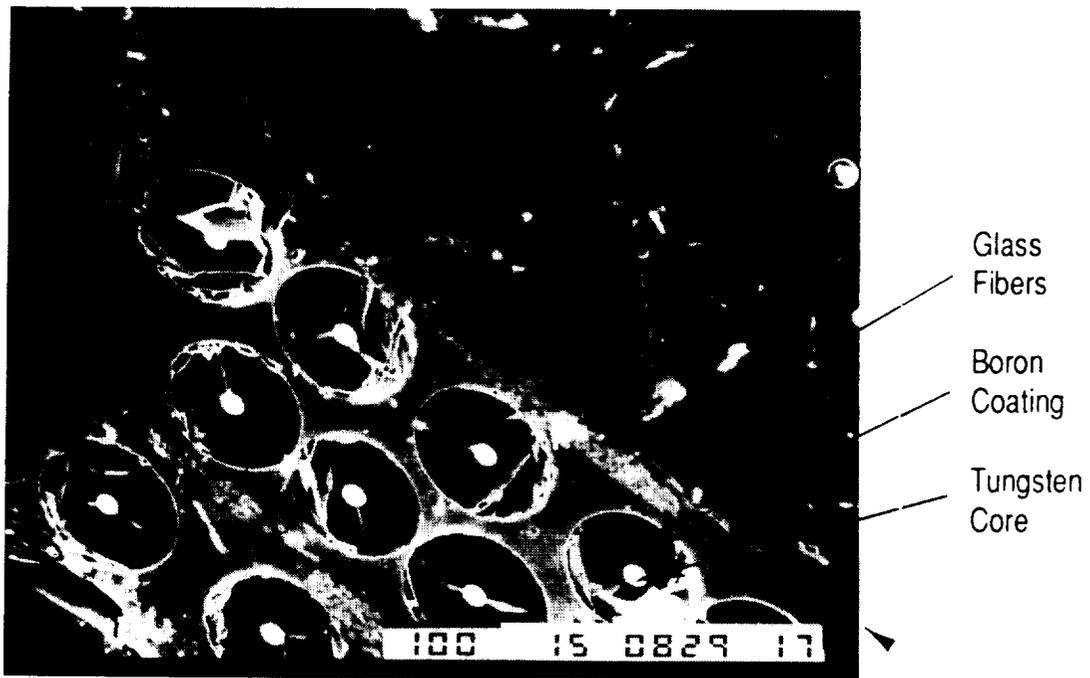
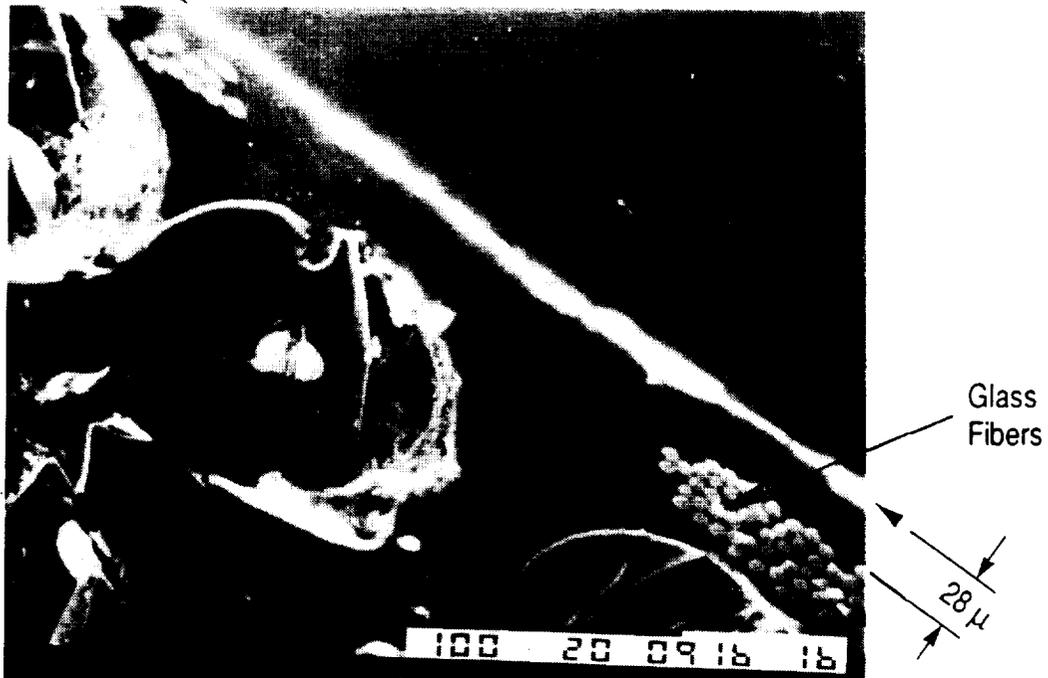
Fig. 2 SEM Photographs of Cross-Section of Unexposed Boron/Epoxy Tube [SP-290,  $(\pm 45^\circ)_4S$ ]. (Arrows delineate boundary between outer epoxy layer and potting compound)

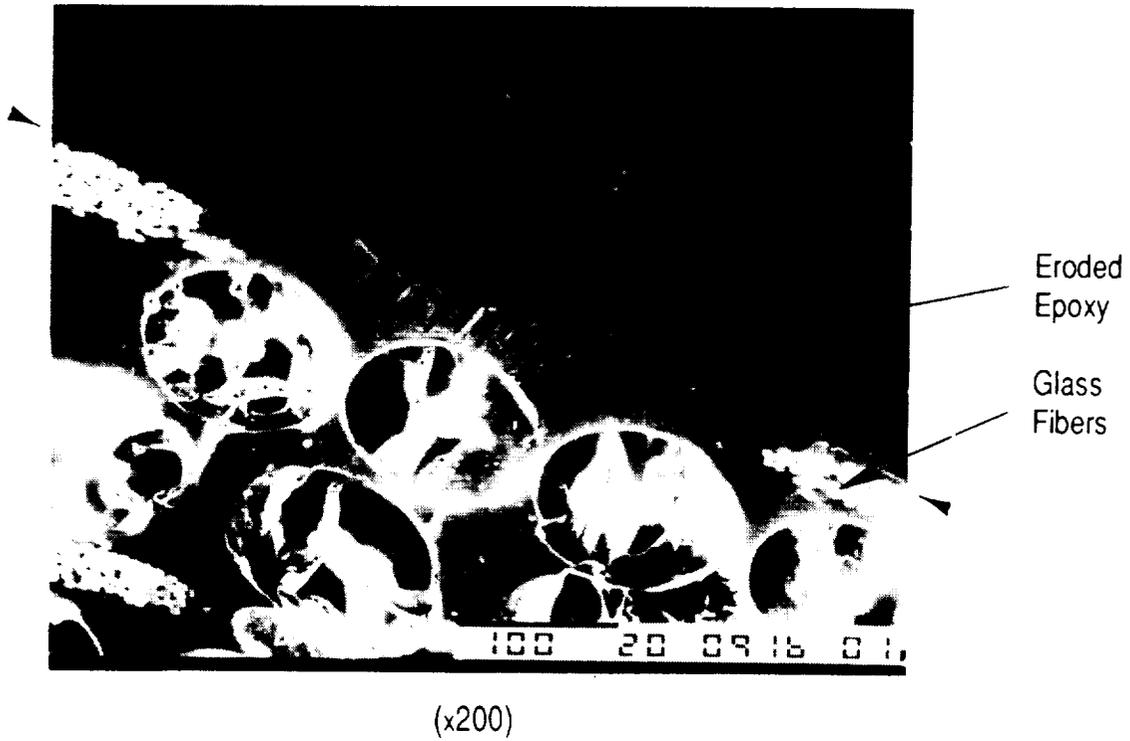
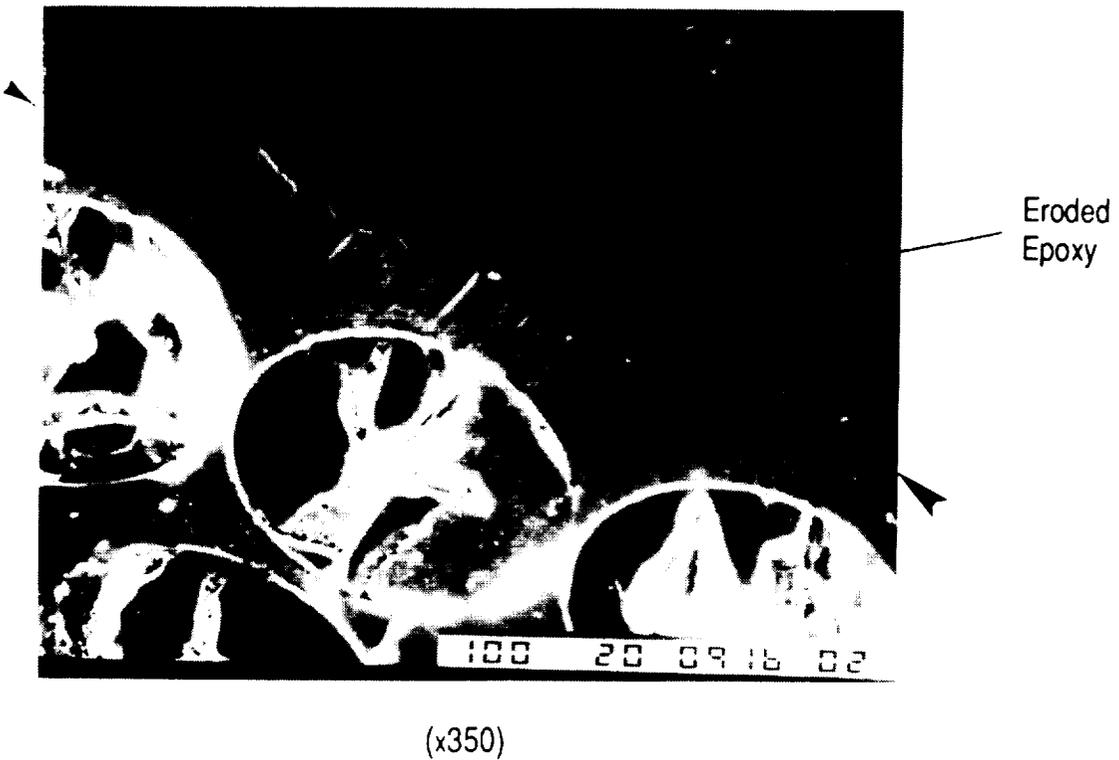
Fig. 3 SEM Photographs of Eroded Cross-Section of Boron/Epoxy Tube [SP-290, ( $\pm 45^\circ$ )<sub>4S</sub>] Exposed to Atomic Oxygen. (Arrows delineate boundary between outer epoxy layer and potting compound)

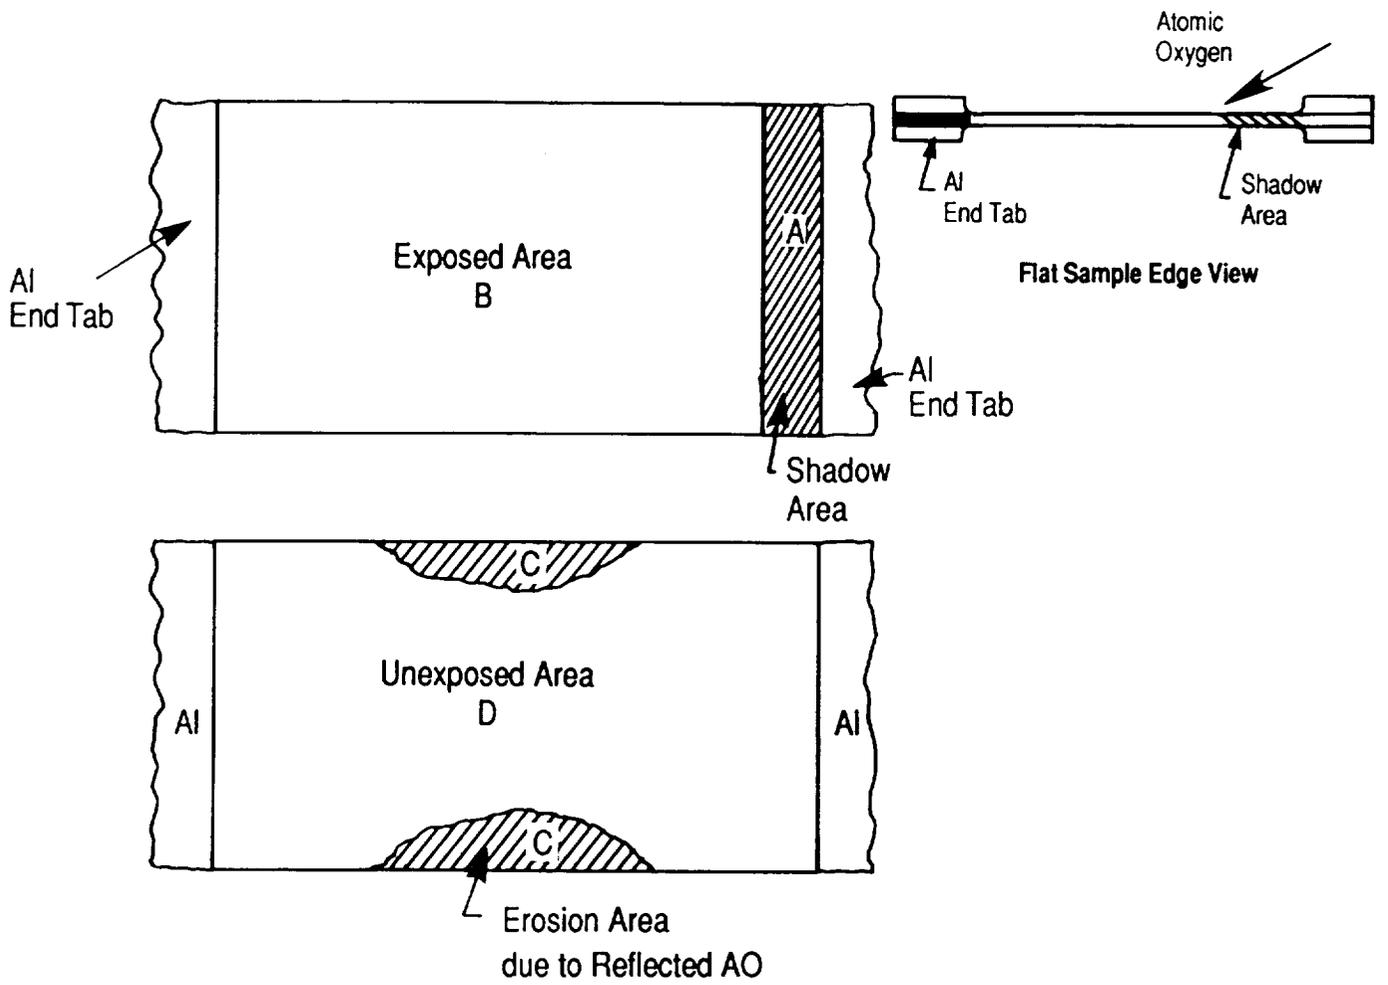
Fig. 6 Kevlar®/Epoxy (SP-328) Flat Plate Laminate

Kevlar®/epoxy flat plate laminates were mounted on the exterior of the UTIAS LDEF experiment. The schematic shown in Figure 6 illustrates a shadow region (A) adjacent to an aluminum (Al) end tab, the outer exposed face (B) and erosion areas (C) on the bottom face (D) which resulted from AO reflection off cylindrical aluminum end fixtures mounted on adjacent tube specimens. Figure 7 presents SEM photographs of two unexposed regions, A and D. These can be compared to the AO erosion surface morphologies found in the exposed areas, B and C. The fibrous nature of the eroded Kevlar® is clearly evident in B, with C more typical of non-directional AO attack on the outer resin layer. Note the difference in texture of the Kevlar® fibers between B and C. In photograph B, the outer epoxy layer is gone and only the partially eroded Kevlar® fibers in the first layer remain.

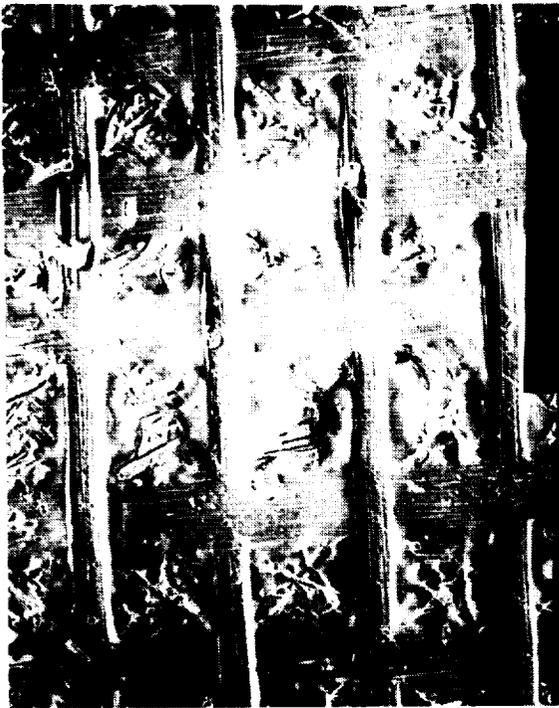
Shadow Area A (x50)

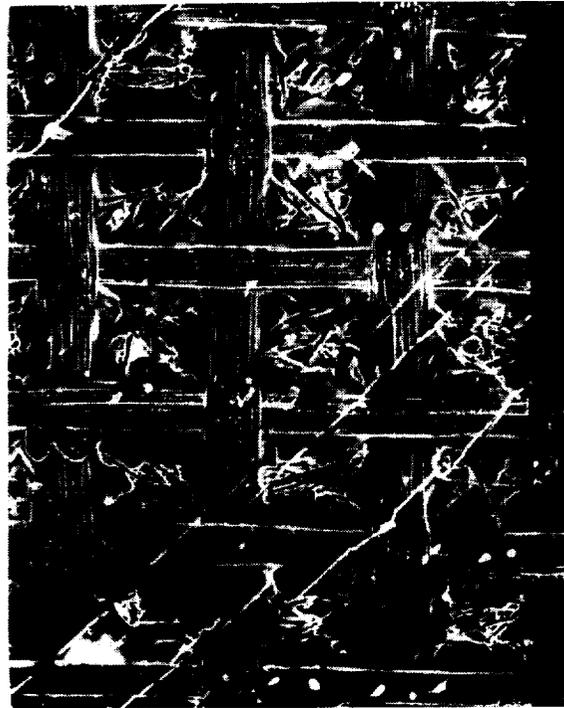
Unexposed Area D (x50)

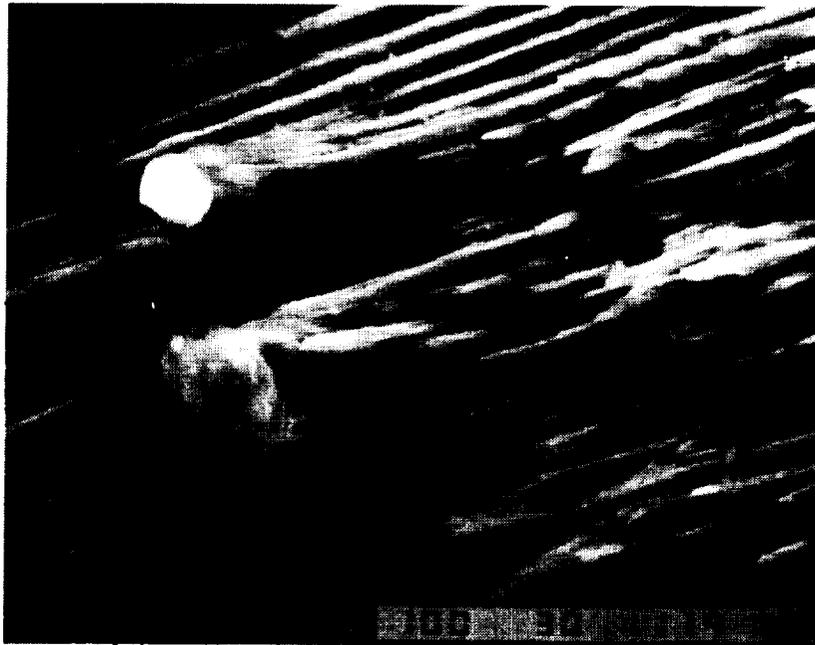
The surface erosion morphology observed on graphite/epoxy laminates due to AO is shown in Figure 8 for a 90°, 4 ply tube (934/T300). When viewing the cross-section of a laminate, one finds that the AO fluence at station D-12 was sufficient to erode the outer epoxy layer and a portion of the reinforcing graphite fibers. Figure 9 presents SEM photographs of unexposed and exposed regions for a ( $\pm 43^\circ$ )<sub>4s</sub> tube (SP288/T300). Erosion of the graphite fibers is clearly evident.

Fig. 8 SEM Photograph of Surface Morphology on Exposed Graphite/Epoxy Tube [934/T300, (90°)<sub>4S</sub>]

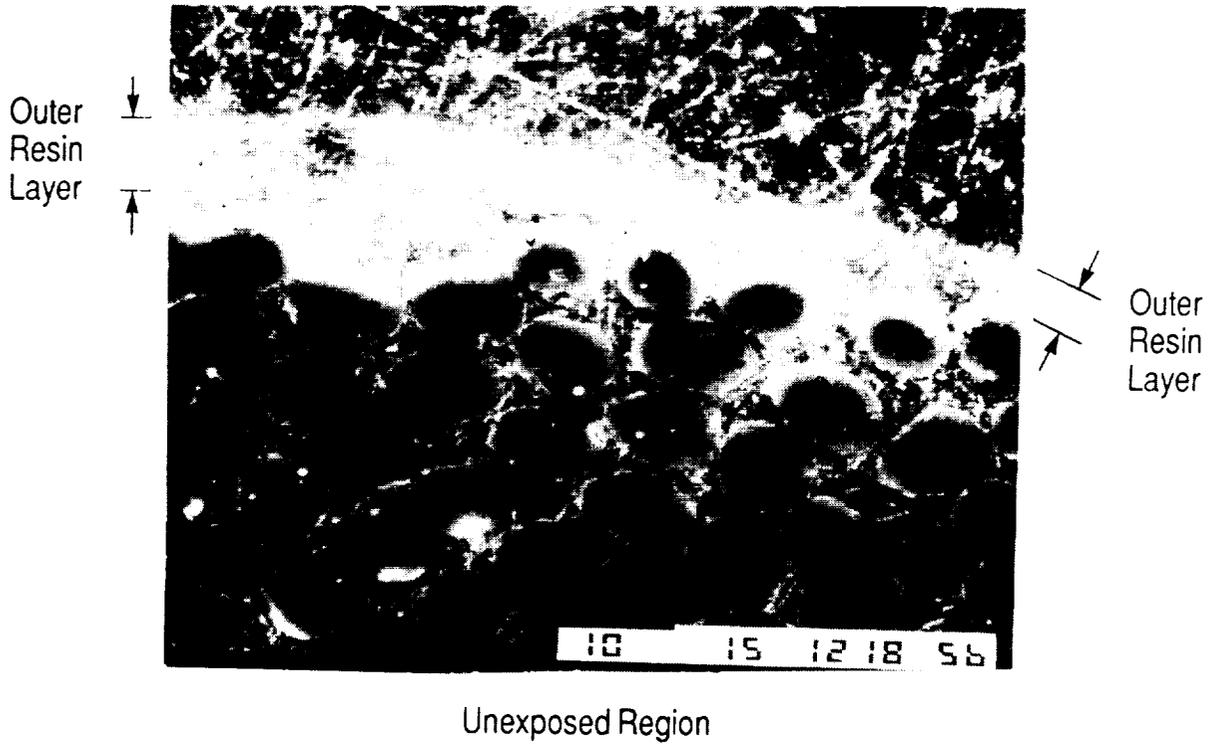
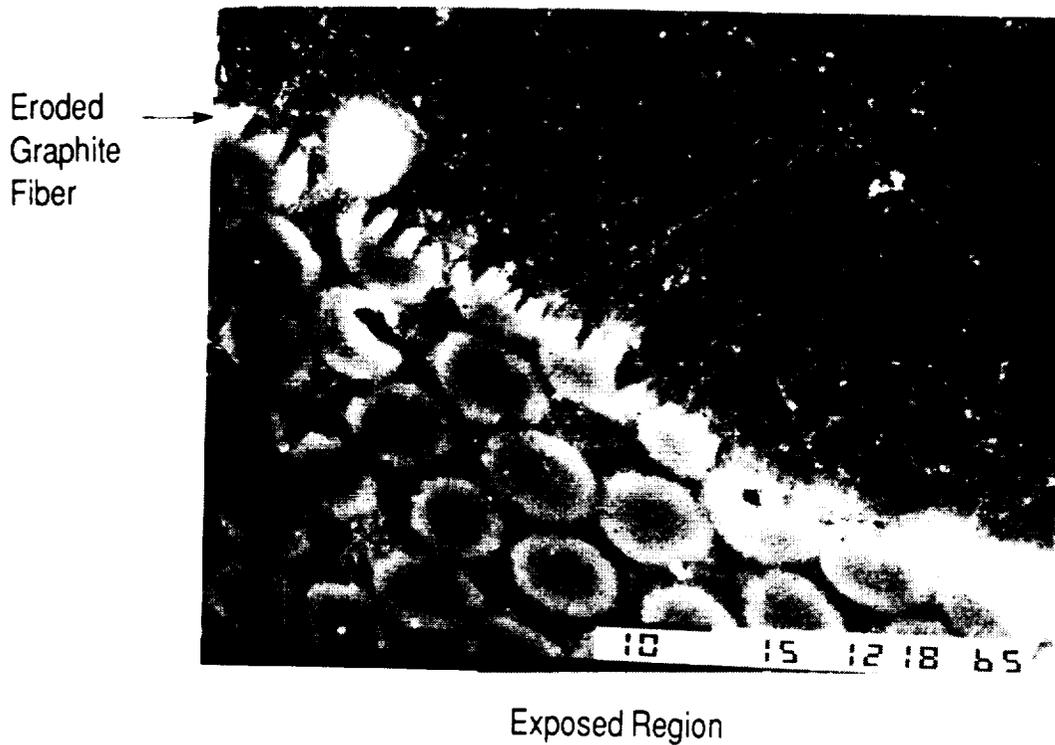
Fig. 9 SEM Cross-Sectional Photographs of Graphite/Epoxy Tube Subjected to AO Erosion [SP-288/T300, ( $\pm 43^\circ$ )<sub>4S</sub>]

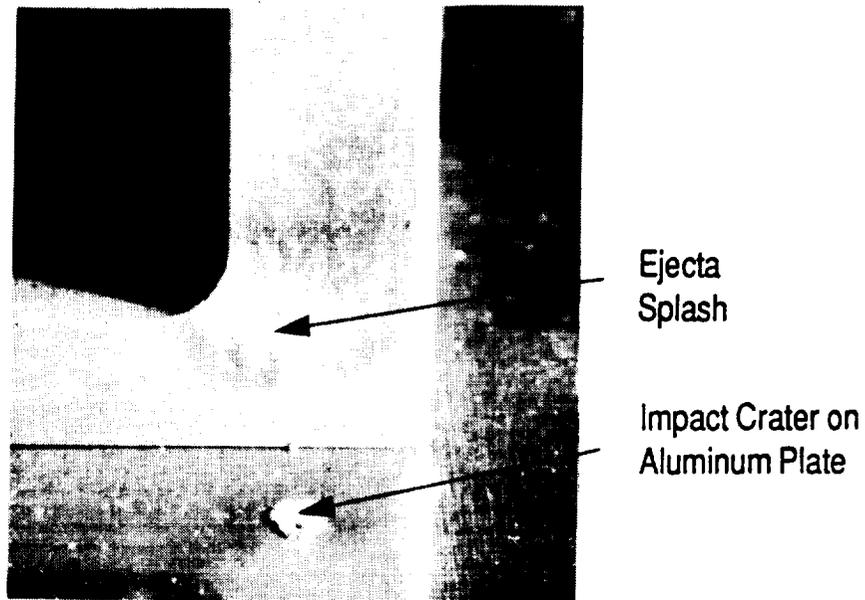
The largest impact found on experiment AO180 occurred on an aluminum base plate, with an ejecta splash observed on an adjacent flange structure (Figure 10). A view of the 1 mm diameter crater is shown in Figure 11. EDS spectra of the crater rim material composition (Figure 12) exhibits a strong Fe peak along with the Al substrate. Based on this evidence it is assumed that the crater resulted from a micrometeoroid impact. Figure 13 contains a SEM photograph of the surface ejecta splash pattern on the flange structure. Details of the different splash patterns in this region are shown in Figure 14. An aluminum ejecta particle, visible in Figure 14, is enlarged in Figure 15 and Figure 16 (lower photograph). Figure 16 presents two different forms of aluminum ejecta particles and their associated splash patterns. The lower photograph shows the remnants of a molten particle while the upper photograph shows the full spherical form of an aluminum particle.

Fig. 10 View of Micrometeoroid Impact Crater and Ejecta Splash Pattern on Adjacent Vertical Flange Structure

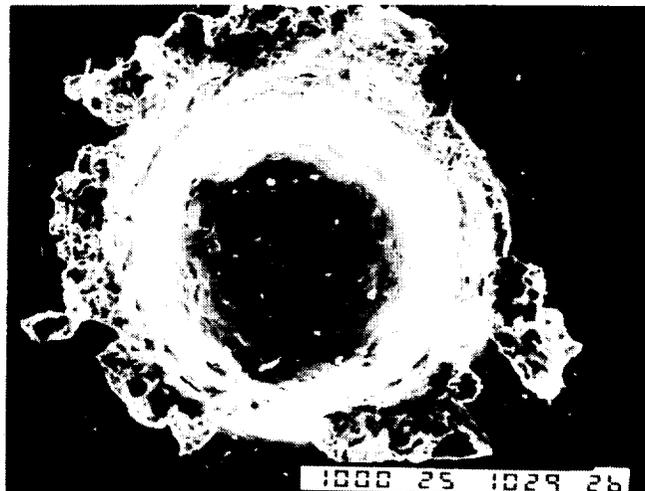
Fig. 11 View of Micrometeoroid Crater on Aluminum Base Plate

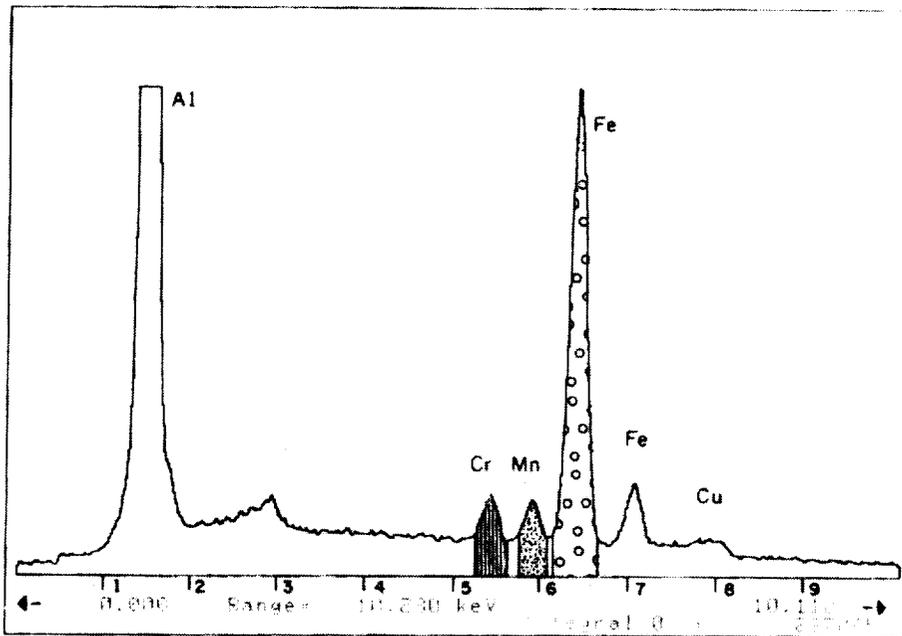
Fig. 12 Crater Ejecta and Elemental Composition (EDS Spectra)

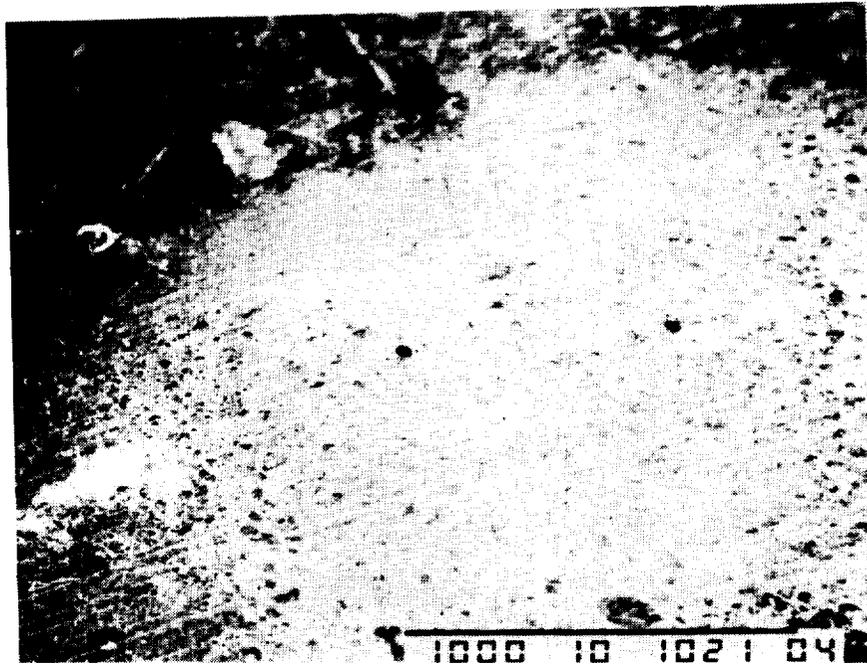
Fig. 13 Ejecta Splash Pattern on Vertical Flange Structure Adjacent to Crater

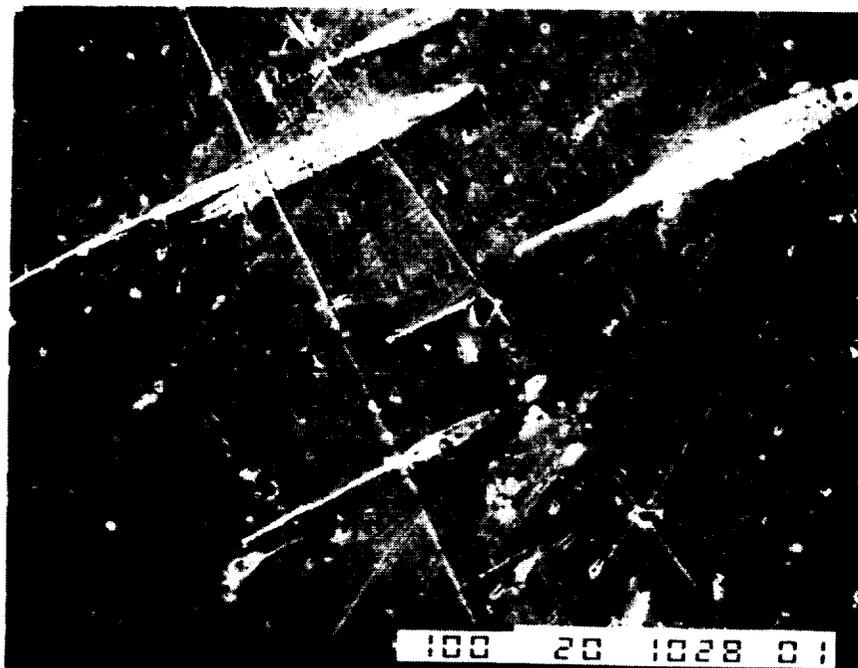
Splash  
Pattern

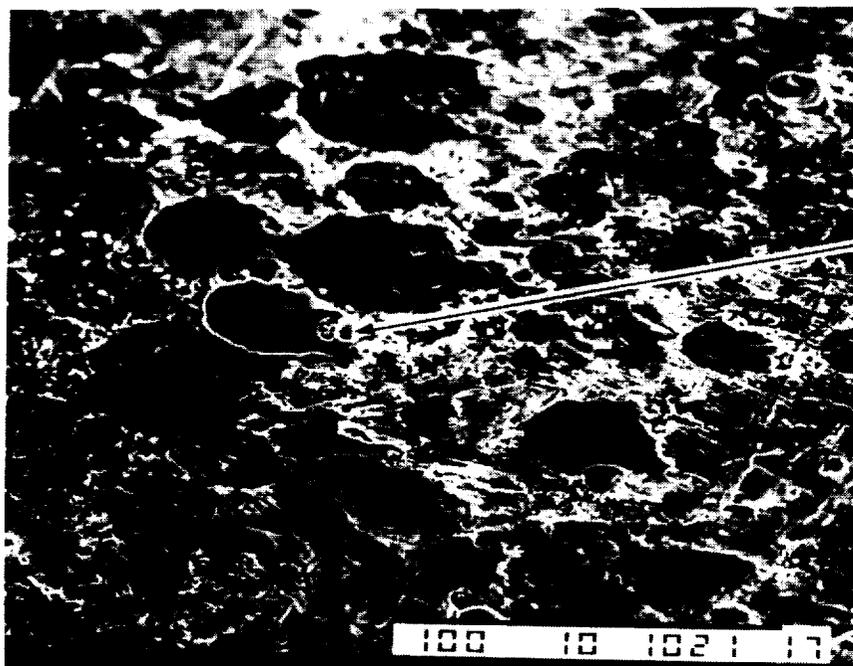
Al Particle and its  
Splash Pattern

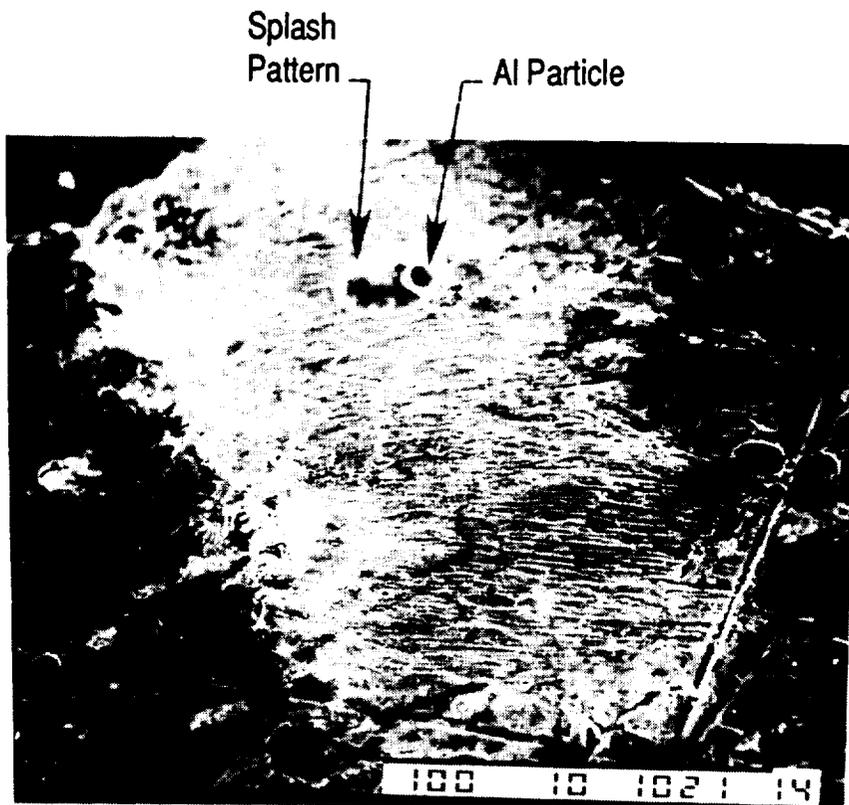
Fig. 15 Superposition of Aluminum Ejecta Particle on Splash Pattern

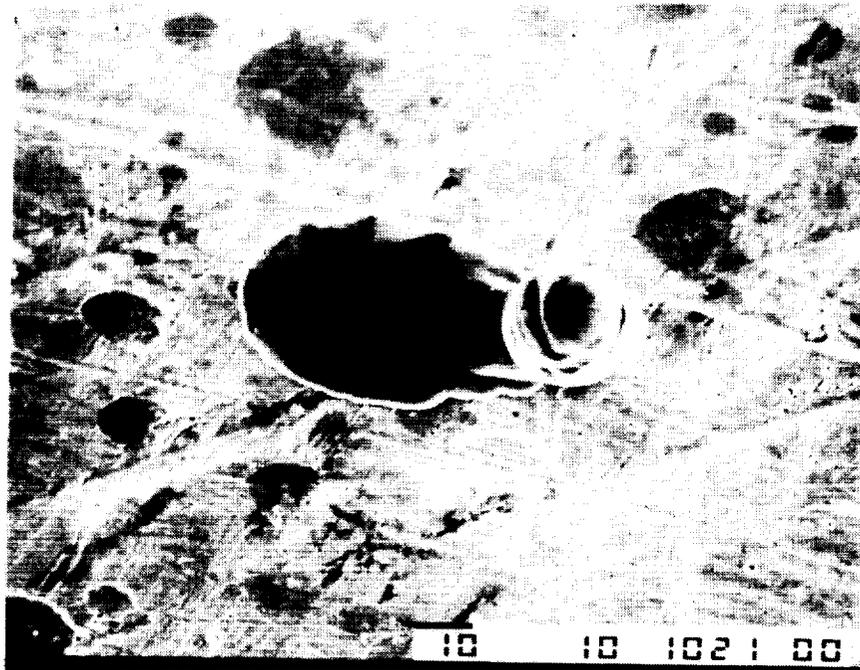
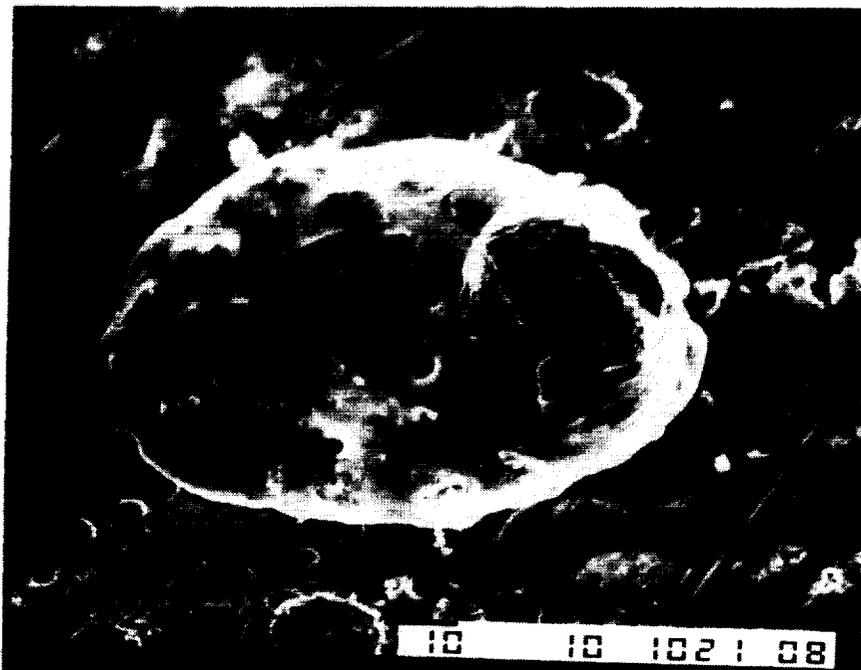
Fig. 16 Aluminum Ejecta Particles with Associated Splash Patterns

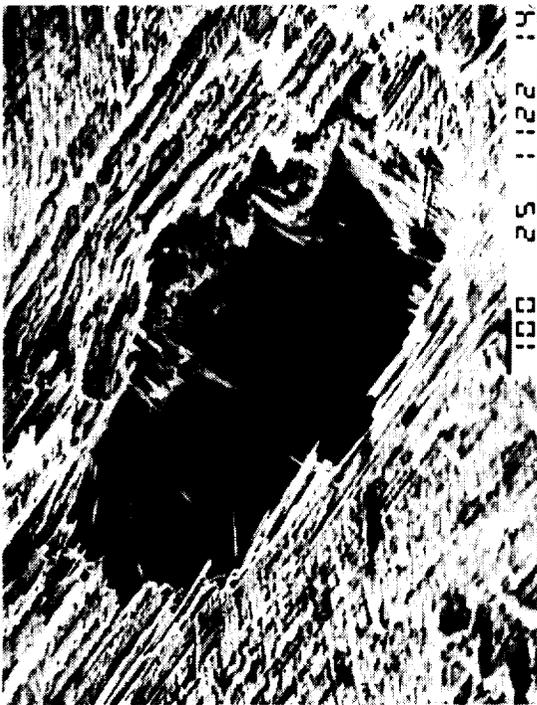
Impact Hole - Exposed Surface  
(x100)

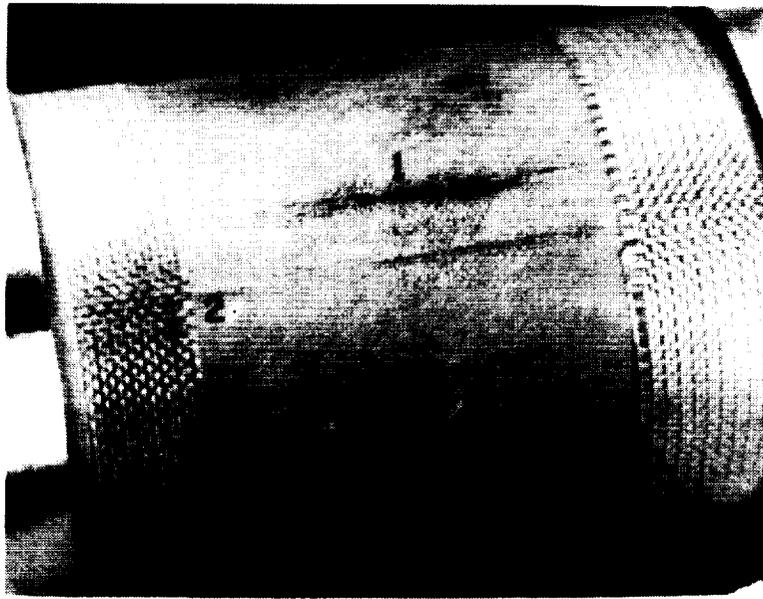
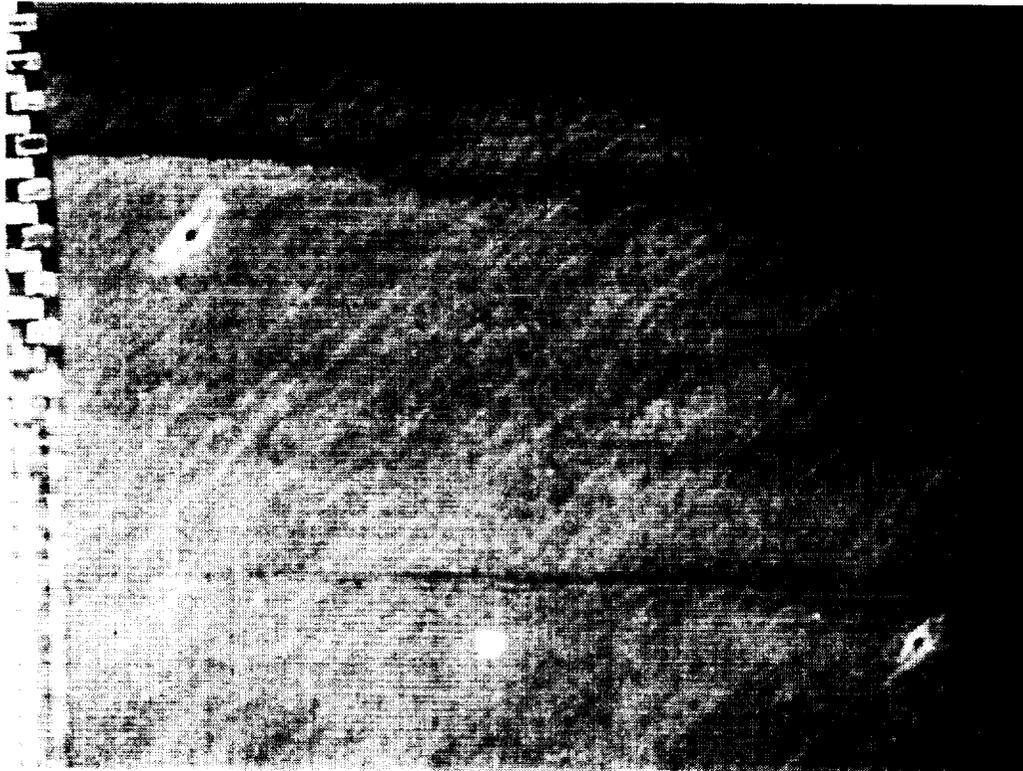
Fig. 18 Micrometeoroid/Debris Impacts on Kevlar®/Epoxy Tube [SP-328, ( $\pm 45^\circ$ )<sub>4S</sub>]

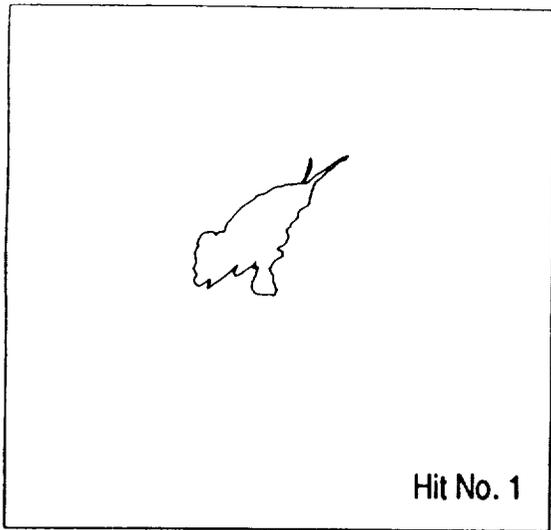
Hit No. 1

Surface Damage Area = 0.223 mm<sup>2</sup>  
Extent of Penetration = 1 - 2 plies

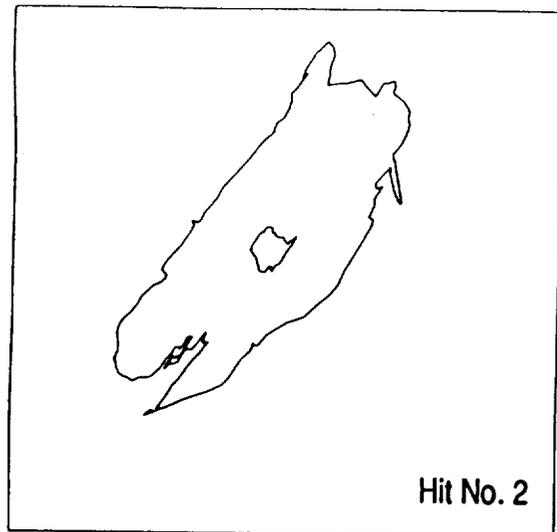
Hit No. 2

Surface Damage Area = 1.445 mm<sup>2</sup>  
Crater Area = 0.033 mm<sup>2</sup>  
Crater Diameter = 0.204 mm  
Extent of Penetration = 2 - 3 plies

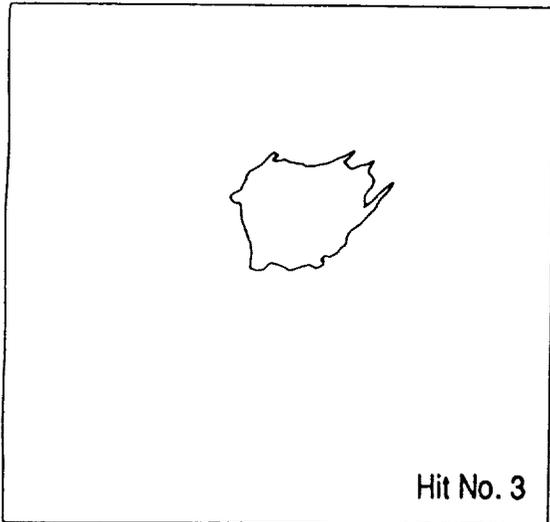
Hit No. 3

Surface Damage Area = 0.370 mm<sup>2</sup>  
Extent of Penetration = 0 - 1 plies

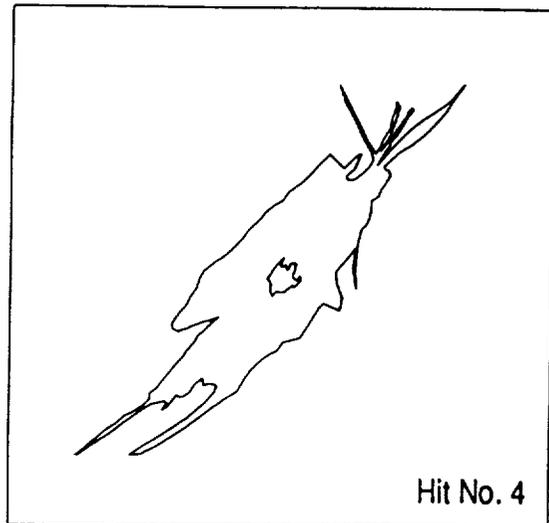
Hit No. 4

Surface Damage Area = 0.881 mm<sup>2</sup>  
Crater Area = 0.020 mm<sup>2</sup>  
Crater Diameter = 0.159 mm  
Extent of Penetration = 2 - 3 plies
